SERVICE BULLETIN #119

18 December 1985

SUBJECT Welds on the lower frame of the Classic IX basket

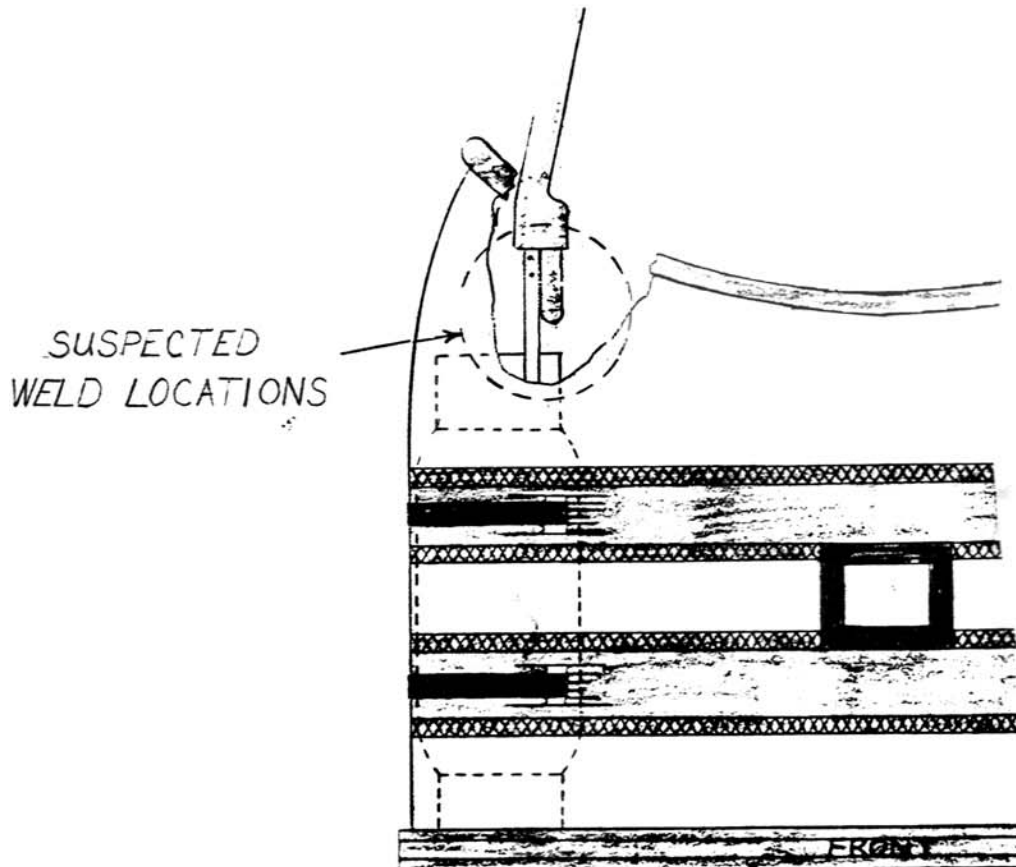
FIGURE 1

PROBLEM A recent failure of one of these tubes indicated that the welding procedure which was used in these cases may have left impurities in the weld filler material. This may act as a stress concentrator in the weld resulting in stress cracking induced by fatigue.

PROCEDURE The upper twelve inches of each end of the lower frames on the Classic IX basket should be visually inspected for the presence of an area which has been welded (See Figure 1). This will be characterized by an area which is approximately 3/8 of an inch in diameter which has been buffed down after welding. Also, the inside of the tube can be examined for the presence of a small weld bead approximately 1/4 inch in diameter.

If a weld location(s) is found, a further inspection of the weld must be made. This will be done by performing a dye-penetrant inspection on the weld area (See Note). This inspection must be performed

If porosity or stress cracking is detected, RAVEN Ind. should be contacted immediately to obtain information and materials to repair the load frame. That contact should be made either by telephone (605-336-2750, HAB SALES) or the enclosed card depending on the urgency of performing the repair. The basket will be considered unairworthy until this repair has been performed.
