AEROSTAR INTERNATIONAL, INC.
SERVICE BULLETIN 134

November 14, 1994

SUBJECT: Interface pin breakage on Classic VIII (RB5), Classic IX (RB6) and Classic X (RB8) baskets.

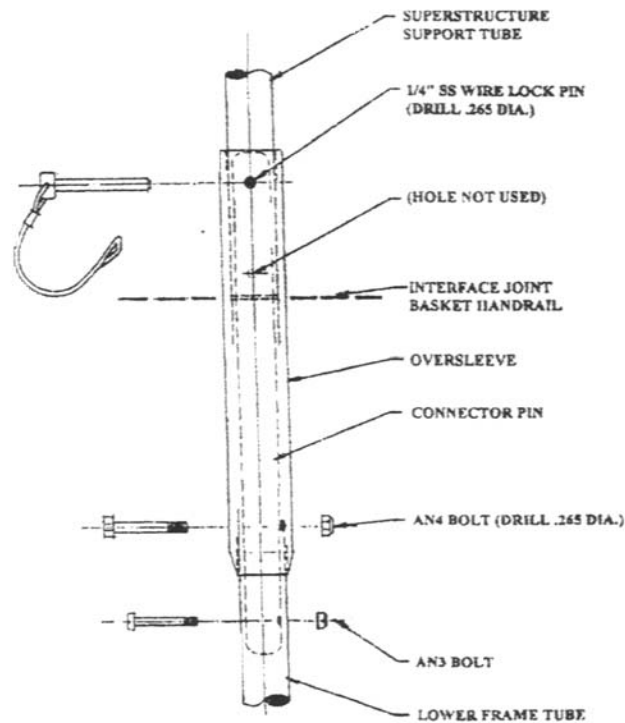
Figure 1 - RB Oversleeve installation

PROBLEM: The aluminum interface pins used in the Classic VIII, Classic IX and Classic X baskets may be susceptible to failure under certain circumstances. Severe impact and dynamic overloading of the frame may cause breaking of the interface pin.

DISCUSSION: On several occasions we have had reported severe bending and/or breaking of the interface pins in Classic IX and Classic X baskets when flown at gross lift conditions in wind or restraint circumstances creating abnormal stresses or torquing of the superstructures. Laboratory testing of the failed parts indicated that the aluminum interface pin when subjected to this type of stress or impact may fail.

6. Drive the oversleeve (P/N 53034) with the chisel-end first through the handrail opening and the wicker woven over the lower frame tube. Use a rubber hammer or a wooden block to avoid damaging the top edge of the oversleeve. Note that there is an orientation to the sleeves (-01 and -02) so that the top hole will line up properly with the hole in the upper support tube.

8. Align the bottom hole of the oversleeve at the top hole of the lower frame, and bolt the sleeve in place using the new aircraft bolt and locknut provided (P/N 51013-28 and 51015-10).

9. Place the superstructure support tube in position in the oversleeve, and using the sleeve as a guide, drill out the support tube and connector pin to .265" diameter, taking care to maintain the existing hole alignment. (Note the bottom hole in the support tube is no longer used). Check the 1/4" wire lock pin (51011-29) for a smooth fit in the hole, and redrill and/or deburr as needed.
