AEROSTAR CONTINUED
AIRWORTHINESS INSTRUCTIONS

AEROSTAR (RAVEN) HOT AIR BALLOONS

ACAI
PART II

Type Certificate No. A15CE

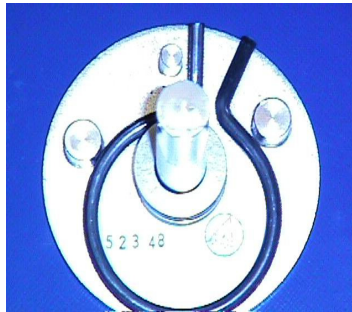
Photo 6.2.13a

- (D) Inspect the hole in the burner frame for elongation or excessive wear with a dial caliper. The hole should not be elongated to a diameter greater than 0.540" in any direction. Inspect the bearing, clean as needed. Apply a small amount of Krytox lubricant to the bearing and washers.
- (E) Assemble the stack of washers and bearing on the gimbal plate shaft as applicable and shown in figure 6.2.13(a)
- (F) Place the gimbal plate with washer/ bearing stack in a bench vice with the inside surface of the spring plate flush with the top of the vice, (shaft pointing upward), and tighten securely.
- (G) With the smaller center pin in the 12:00 o'clock position, place the legs of the spring at the 1:00 o'clock position, between the smaller center pin and the larger pin to the right. (See photo 6.2.13a)

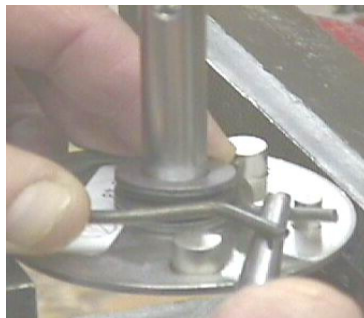
Photo 6.2.13b

- (H) Using a tapered drift tool, twist the right leg of the spring past the left leg and over the small center pin while holding the spring flat against the plate with the other hand. (See photo 6.2.13b)

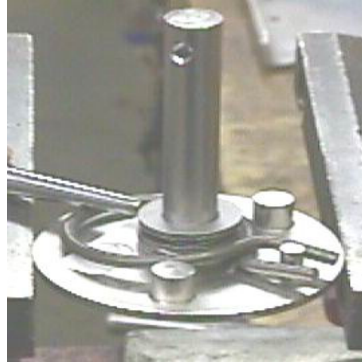
Photo 6.2.13c

Tap the legs down securely over the small center pin (while still holding the spring against the plate). Then tap the legs of the spring towards the center of the plate so that the legs do not overlap past the plate edge, while holding the spring down to the plate with a tapered punch or similar tool. (See photo 6.2.13c)
